DIESEL FUEL LUBRICITY

ASTM D6079 Evaluating Lubricity of Diesel Fuels by the High-Frequency Reciprocating Rig (HFRR)

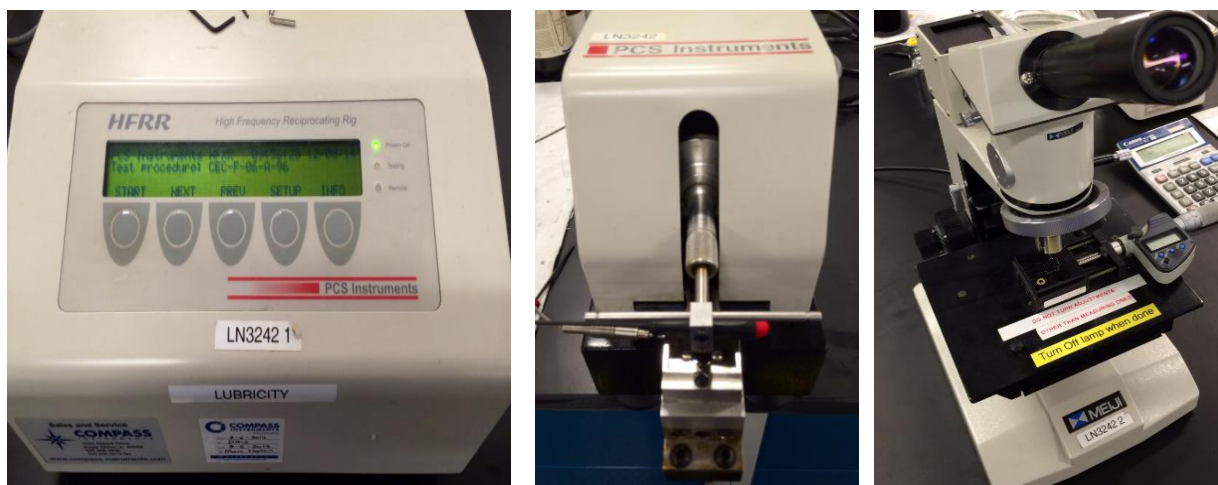
HFRR Unit at AmSpec Avenel NJ

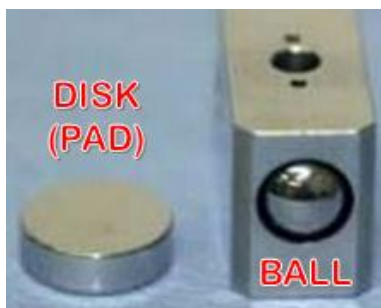
4.2 When the fuel temperature has stabilized, a vibrator arm holding a non-rotating steel ball and loaded with a 200-g mass is lowered until it contacts a test disk completely submerged in the fuel. The ball is caused to rub against the disk with a 1-mm stroke at a frequency of 50 Hz for 75 min.

4.3 The ball is removed from the vibrator arm and cleaned. The dimensions of the major and minor axes of the wear scar are measured under 100x magnification and recorded.

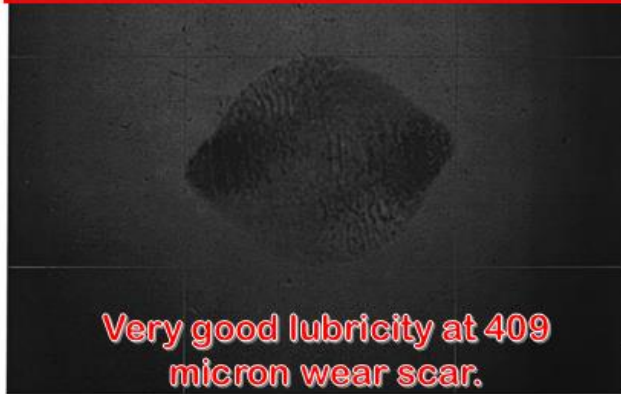
WEAR SCAR MEASUREMENT - TK ████ **8.12.14**

Measurement 1 of 1 taken by db on Tuesday, August 12, 2014 11:20 AM
Wear Scar X: 460 um Wear Scar Y: 357 um Wear Scar Avg: 408.5 um

These are test run pictures taken at the AmSpec Paulsboro Lab using the D6079 HFRR microscope camera.

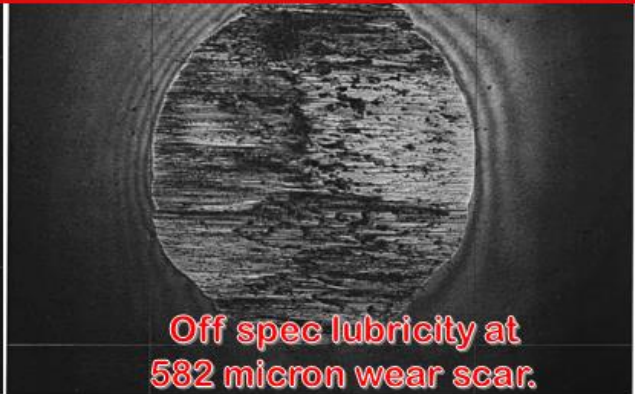
WEAR SCAR MEASUREMENT - ROUND ROBIN

Measurement 1 of 1 taken by JK on Monday, June 30, 2014 3:02 PM
Wear Scar X: 543 um Wear Scar Y: 620 um Wear Scar Avg: 581.5 um
